Public buildings as shining examples for a better energy efficiency in Europe

### **BRITA in PuBs**

The Integrated Project (IP) of the European Commission BRITA in PuBs - Bringing Retrofit Innovation to Application in Public Buildings - has received funding from the EU 6th Framework Programme under the contract: TREN/04/FP6EN/S07.31038/503135

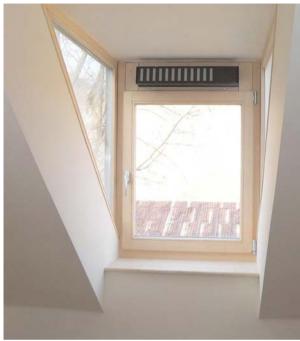
New glazing...

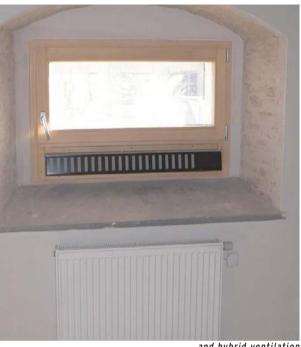
...and hybrid ventilation

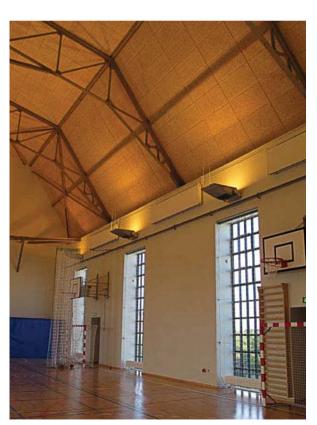
Upper floor and isolated roof

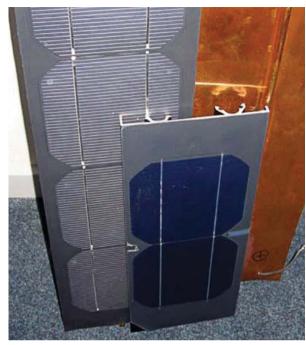
PV-T plant

Two kinds of PV plants are installed at Proevehallen; One at the gable (19 kWp) which is made with an artistic expression and one innovative PV-T plant (6 kWp) which also delivers heat by cooling by a heat pump. The cooling raises the efficiency of the PVs. The produced electricity are used in the building or sold to the electricity grid.

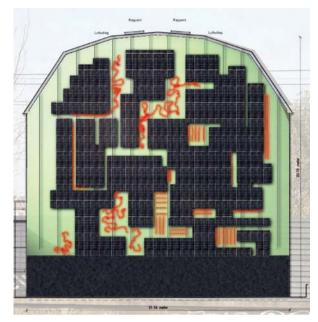
'Artistic' PV on the gable

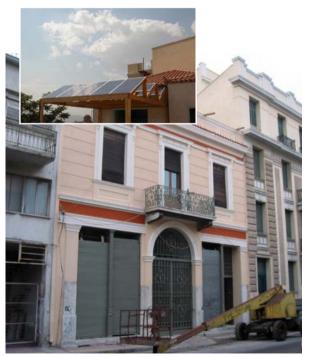
The new facade and the new patio with solar collector
